香港特別行政區政府
民航處

Dangerous Goods Advisory Circular (DGAC) 4/2007

Safe Handling of Nickel-Metal Hydride (NiMH) Battery Packs 〈鎳氫電池組〉 for Air Transport

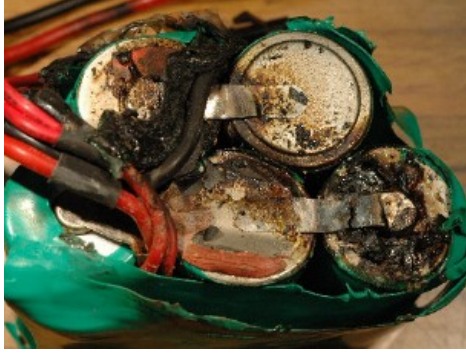
Photo 1

- (a) Each battery pack concerned was containing 5 individual battery cells and they were inter-connected by metal parts within the outer insulation wrappings (Photo 1);
- (b) Rough handling of the battery packs during loading and unloading had probably damaged the insulation wrappings and the bare casing of individual battery cells were then exposed to each other;
- (c) Further impact or vibration during transport had caused an intermittent "bridging" effect between the casing of individual cells. [Remarks: this is not a short-circuiting effect]; and

- (a) thickening the insulation material for individual battery cells;
- (b) insulating the metal connection parts between individual battery cells; and
- (c) improving the plastic bubble packaging etc.

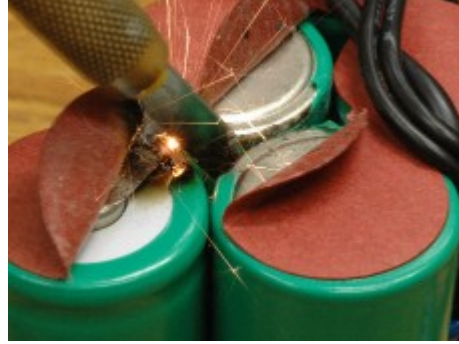
Photo 2

- (d) The “bridging” effect between individual battery cells would have generated electric arcs that were hot enough to ignite the combustible materials inside the battery packs and therefore causing the fire (Photo 2).

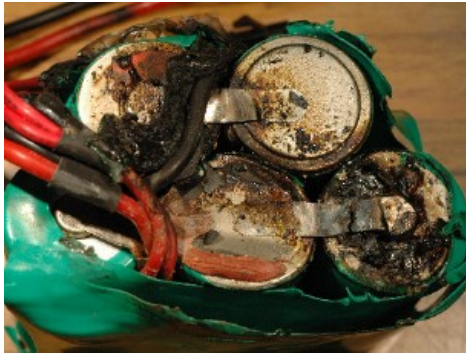
照片一

- (a) 每組電池有五枚電池，外層用絕緣物料包裝，電池之間以金屬零件連接(照片一)；

- (a) 加厚電池的絕緣物料；
- (b) 令連接電池的金屬零件絕緣；以及
- (c) 改善塑膠氣泡包裝等。
